Manhole Inspection Summary

Manhole # S23GG1007MH

Insp Date: **12/11/06 11:37 AM**

Location Address: **1301 42nd St**

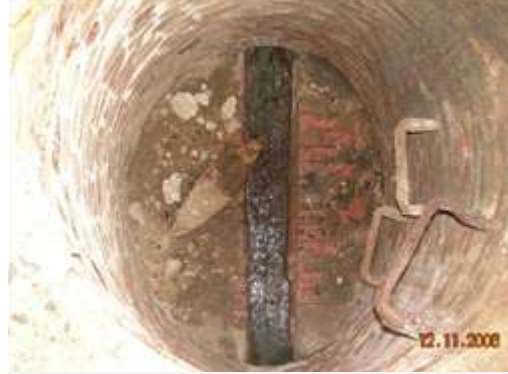
Top View

Infiltration: ☐ None ☐ Joint ☐ Cracks ☒ **Mortar** ☐ Roots ☒ **Wall**

Condition: ☐ Sound ☐ Cracked ☐ Root Intrusion ☐ Deteriorated ☐ Leaks ☒ **Debris**

Steps Count: **3** Missing: **0** ☒ **Corroded**

Corroded steps, bench and channel debris, barrel infiltration

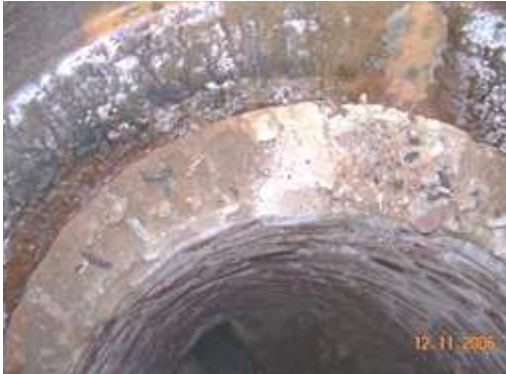
Defect

Frame Offset: **4** (in.) Condition: ☐ Sound ☐ Cracked ☒ **Leaks**

Condition: ☐ Sound ☐ Cracked ☐ Root Intrusion ☒ **Loose Brick** ☒ **Deteriorated**

Infiltration: ☐ None ☒ **Joint** ☐ Cracks ☒ **Mortar** ☐ Roots ☐ Wall

Frame leak, adjustment deterioration and infiltration

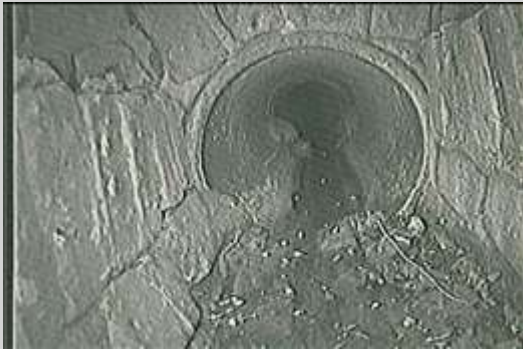
8 in. Circular Gravity Sewer Pipe Out @ 12 O'Clock

Deposits: ☐ None ☒ **Mud** ☐ Sludge ☐ **Debris** ☐ Grease

Silt Depth: **1** (in.) Deposits Extent: **Light**

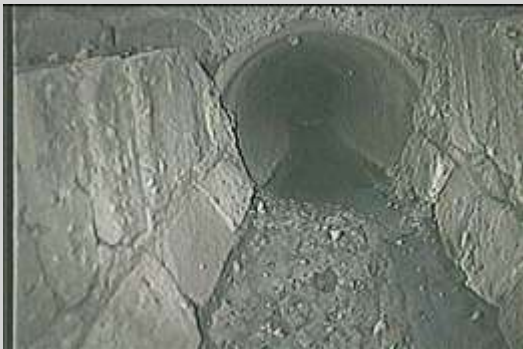
8 in. Circular Gravity Sewer Pipe In @ 6 O'Clock

Deposits: ☐ None ☒ **Mud** ☐ Sludge ☒ **Debris** ☐ Grease

Silt Depth: **1** (in.) Deposits Extent: **Light**
